FEDERAL CENTER FOR TECHNOLOGICAL EDUCATION OF MINAS GERAIS
DEPARTMENT OF SCIENCE AND ENVIRONMENTAL TECHNOLOGY
GRADUATE IN ENVIRONMENTAL AND SANITARY ENGINEERING
DISCIPLINE RECOVERY OF DEGRADED AREAS

Evaluation of the environmental and socioeconomic impacts generated by the rupture of the Fundão dam in Mariana, Minas Gerais.

Academic work presented to the discipline Recuperation of Degraded Areas of the undergraduate course in Environmental and Sanitary Engineering, Federal Center of Technological Education of Minas Gerais.

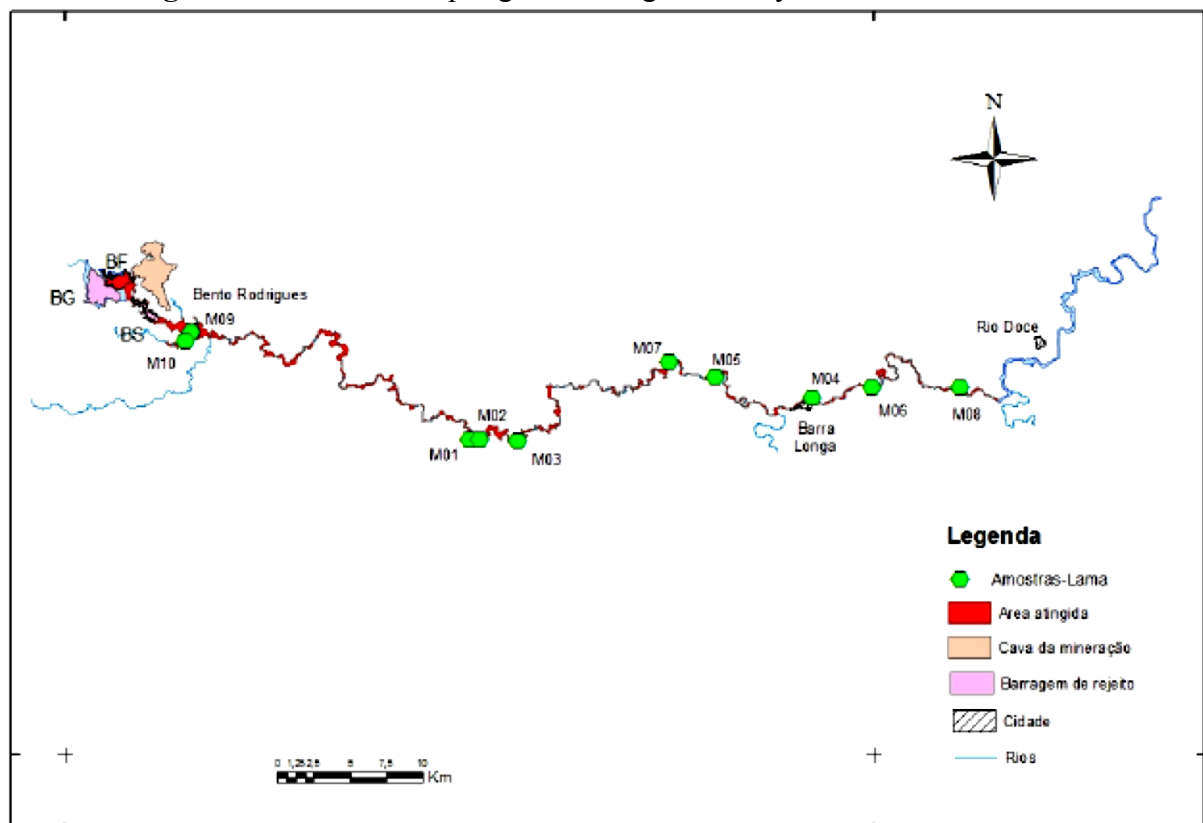
Figure 2: Sediment sampling sites along the valley of the affected rivers.

Embrapa Solos (EMBRAPA, 2015) evaluated the contents of chemical and metallic compounds present in the sedimentated material from the tailings dam at several collection points along the valley of the rivers affected (Figure 2). It should be pointed out that the results indicate lower values than those adopted as reference for the evaluation of contamination of metals in the soil, according to CONAMA (2009).

The results obtained in relation to the physical quality of the soil indicated granulometric homogeneity of the deposited materials, as high levels of fine sand and silt (grain size less than 2 mm) in 90% of the soil fraction. The clay content represented only 10% of this total fraction, significantly reducing the cation exchange capacity (CTC) of the soil (CORREIA; MAGALHÃES, 2016; EMBRAPA, 2015). Considering that the CTC corresponds to the total number of cations that a soil is capable of withholding, due to the amount of its negative charges, it is understood that the CTC reduction of the analyzed soil indicated the low fertility of the soil (MATOS, 2017).

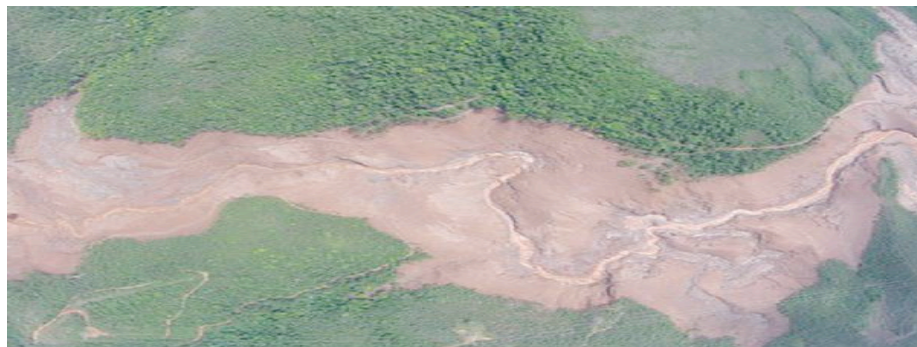
Figure 4. Devastation of the riparian forest due to the rupture of the Fundão dam.

Due to the rupture of the Fundão dam, there was a devastation of approximately 374.81 ha of riparian forest cover (Figure 4) and APPs and, due to the contribution of sediments (waste sludge from the iron ore exploitation), buried the species and suppressed arboreal individuals (MINAS GERAIS, 2016; CORREIA E MAGALHÃES, 2016).

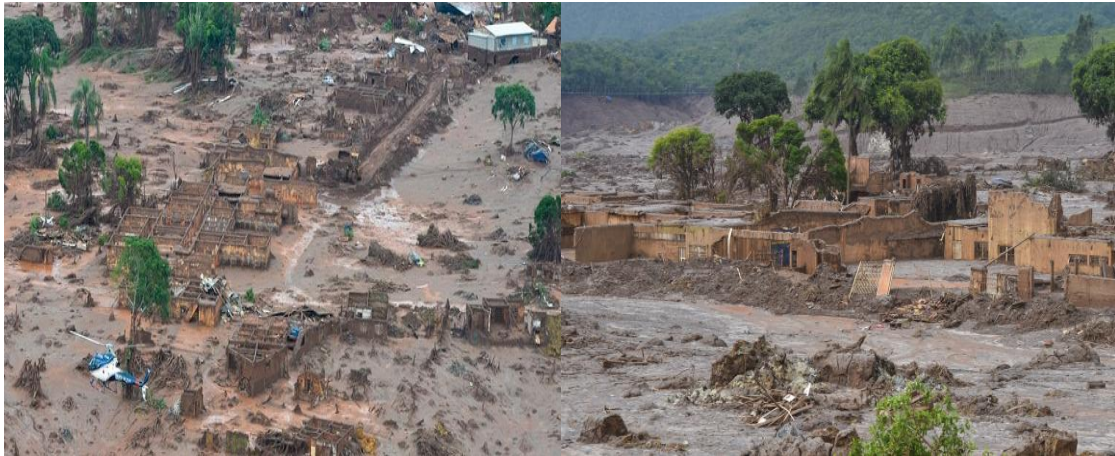
Figure 7. a) e b). Area affected by the rupture of the dam in Mariana.

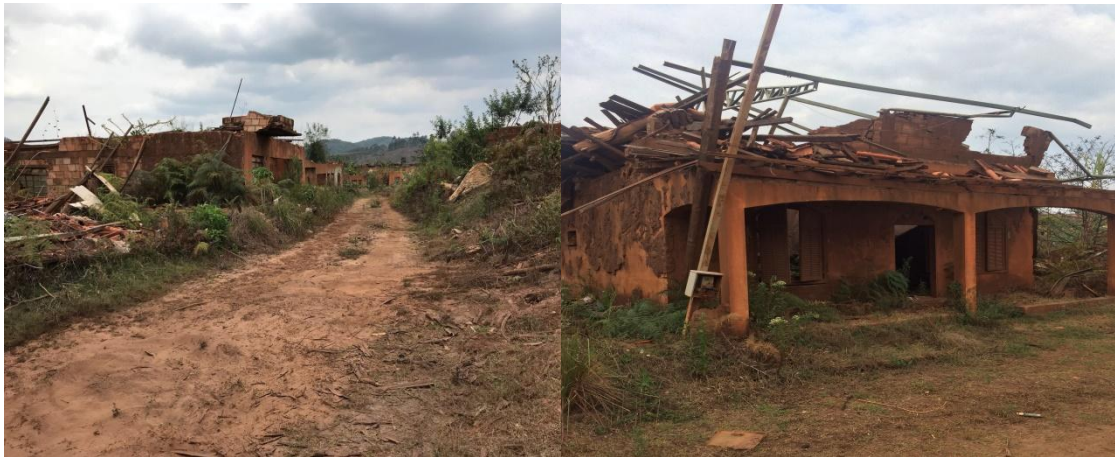
Figure 8. a) e b) Bento Rodrigues scenario two years after the accident.

The District of Bento Rodrigues is compromised, being unfeasible the permanence of people to live (Figure 8). According to coach Stopa, former residents have access to the affected area on Wednesdays, Saturdays, Sundays and holidays from 8:00 am to 6:00 pm. Approximately 30 residents visit Bento Rodrigues on a constant basis.

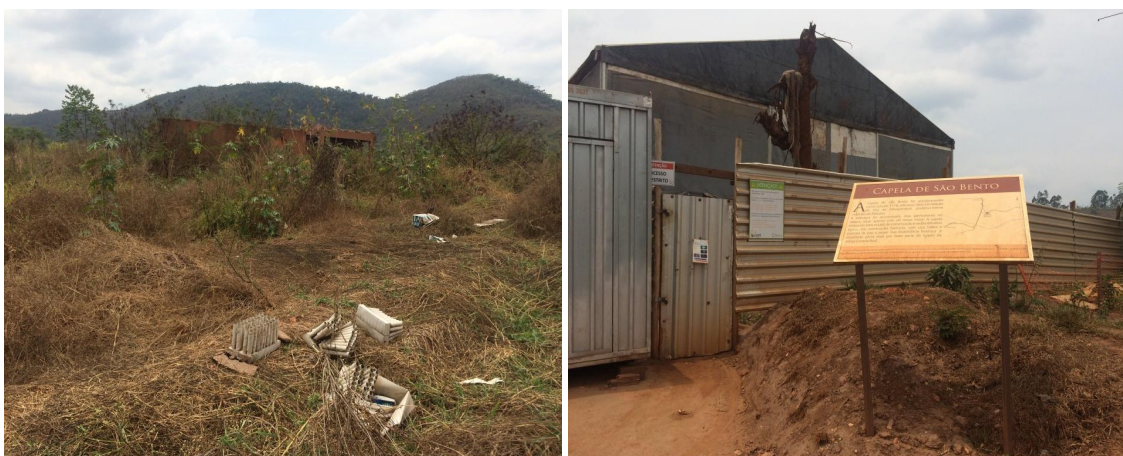
Figure 9. a) Fireworks for celebrations b) Bento Rodrigues Church two years after the accident

There are still commemorative and religious celebrations held in the city, receiving in those times a greater number of former residents. With this, we realize that even after the tragedy, the essence and culture of the community was not lost. Bento Rodrigues owned a church, which represents a symbol of the community. Archaeological studies are underway for its recovery (Figure 9).

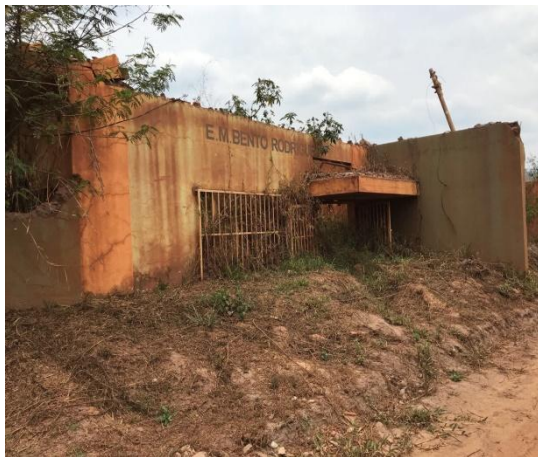
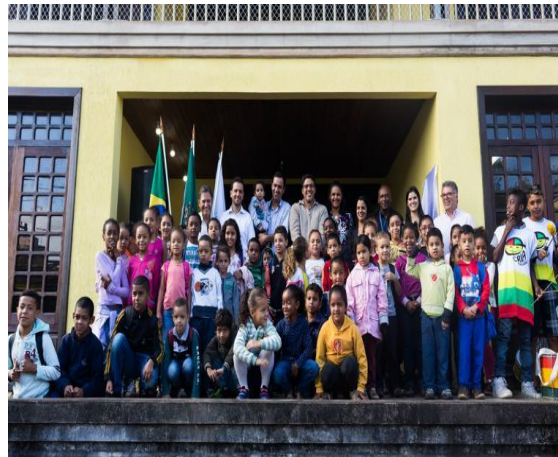
Figure 10. a) School in Bento Rodrigues two years after the accident **b)** New school of Bento Rodrigues located in Mariana-MG.

Regarding education, a school was built in a house for the community of Bento Rodrigues and Paracatu, maintaining the same organizational body of the existing school in Bento Rodrigues before the accident (Figure 10).

Unfortunately, it is seen that the children affected by the accident are discriminated against by the population of Mariana. Second (El Pais, 2016) these children are called "mud boys" by other colleagues.
